Portage Creek Sediment Remediation Project Kalamazoo, Michigan

Post-Sediment Removal Structure Feature Assessment Removal Areas SA5-Axtell, SA5-D and SA5-C

F&V Project Number: 809930
October, 2012

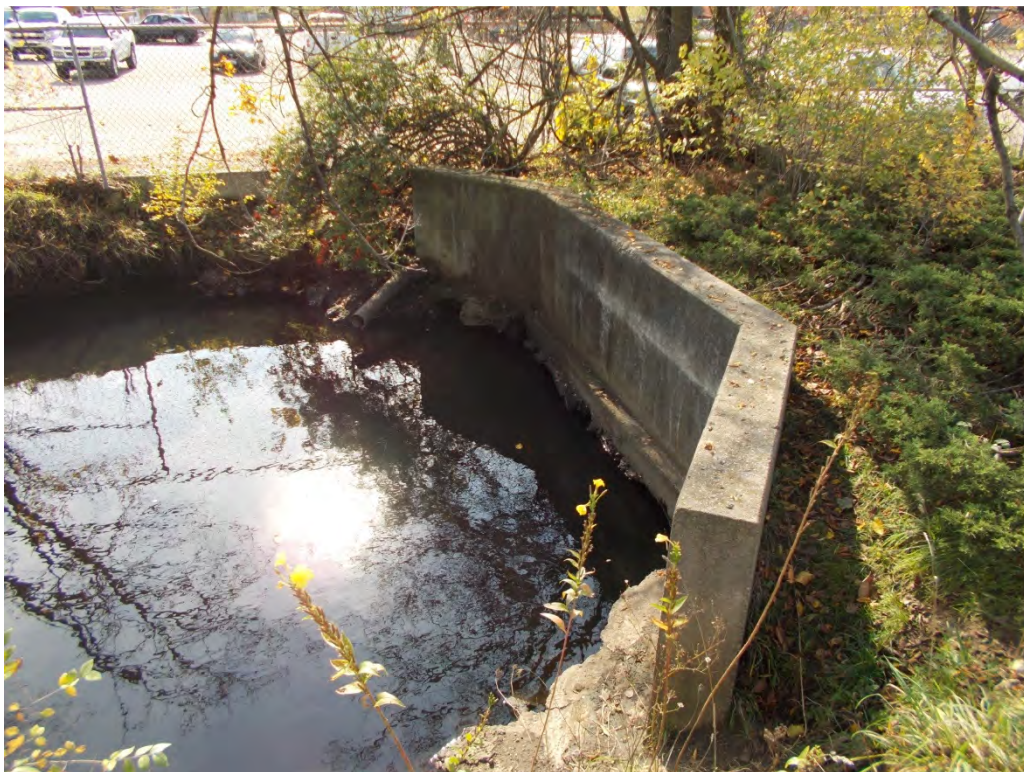
Designation: SA5-Axtell-S01

- The structure does not appear to have been impacted during sediment removal.

Structure viewed from the north bank

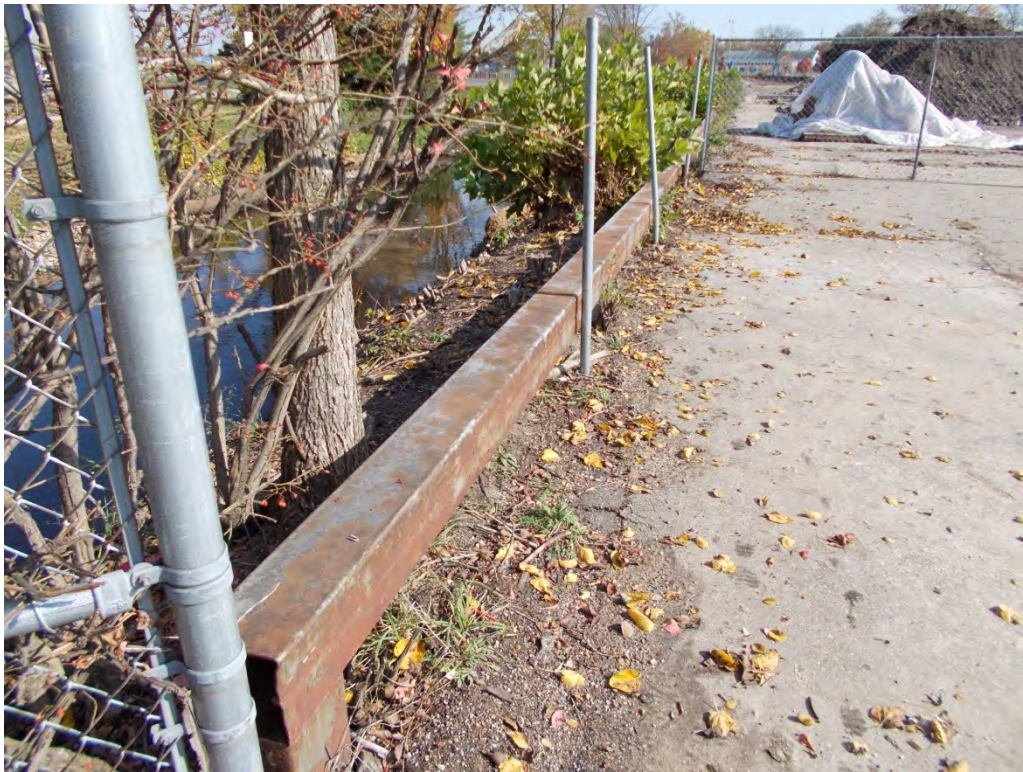
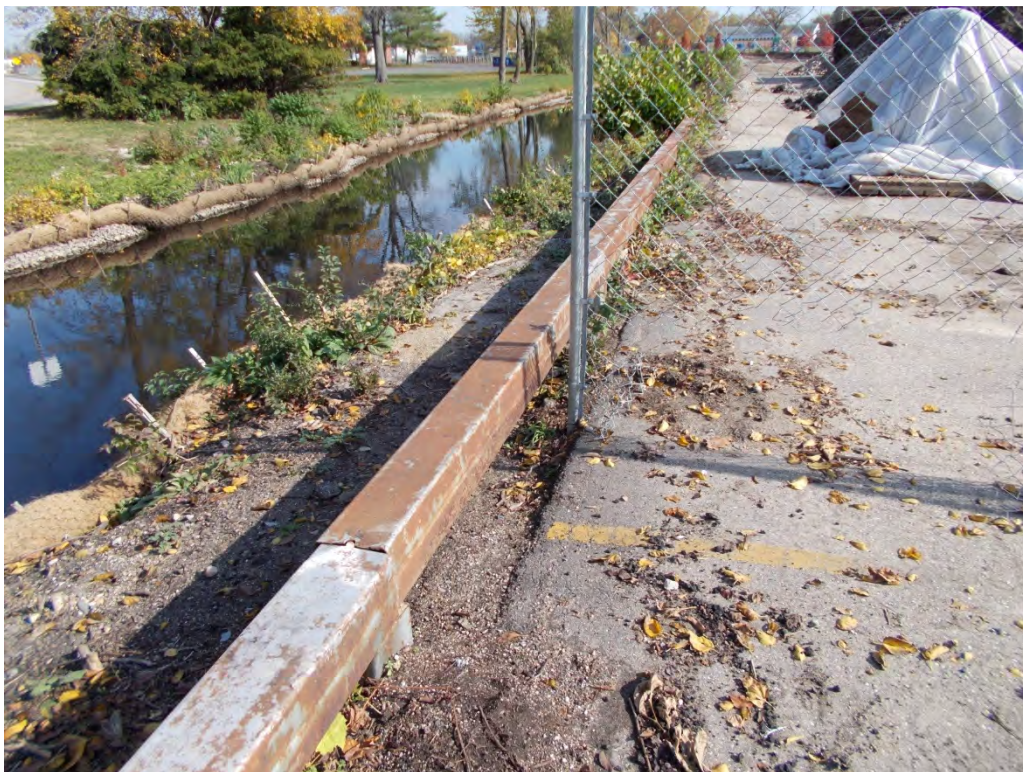
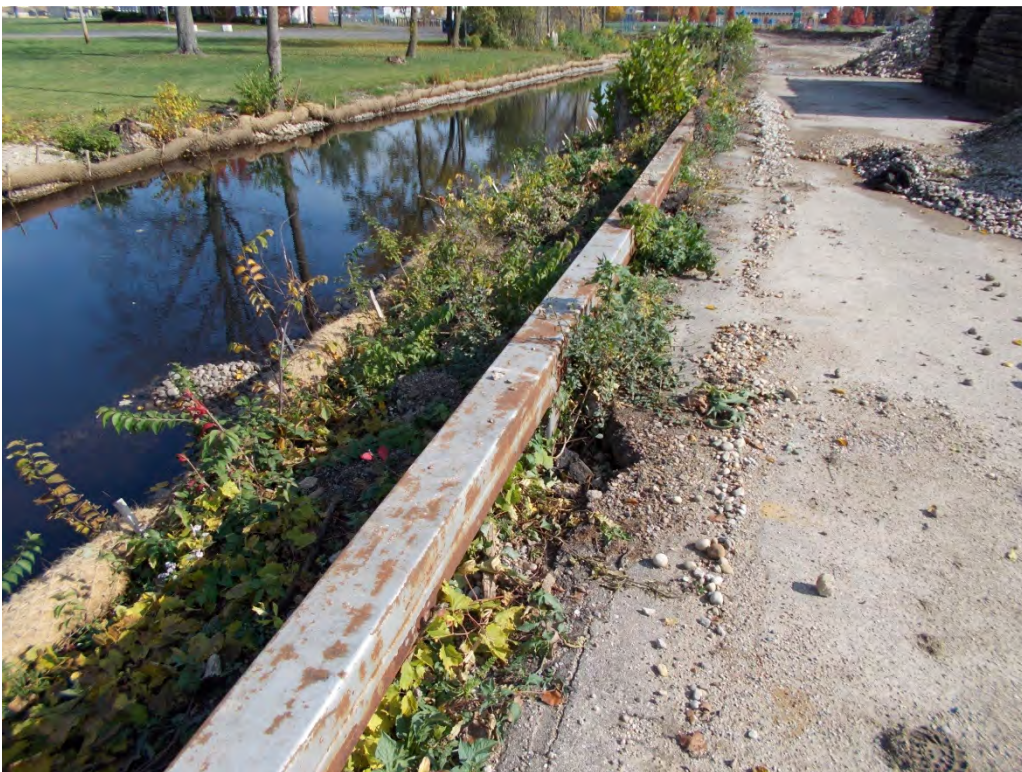
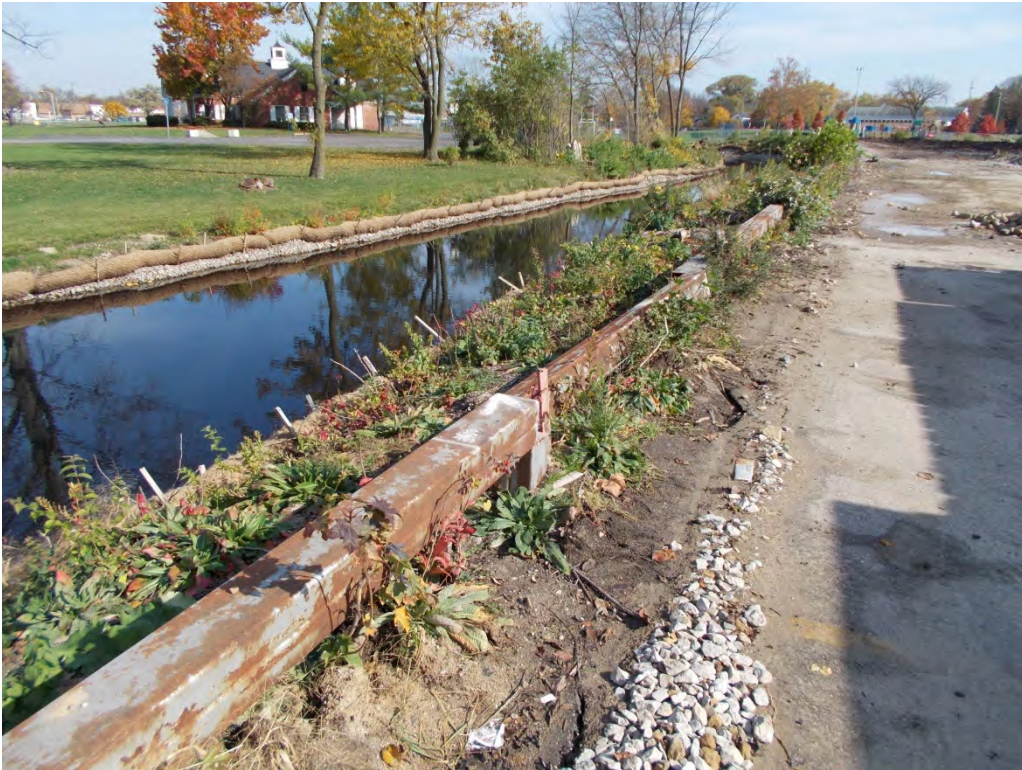
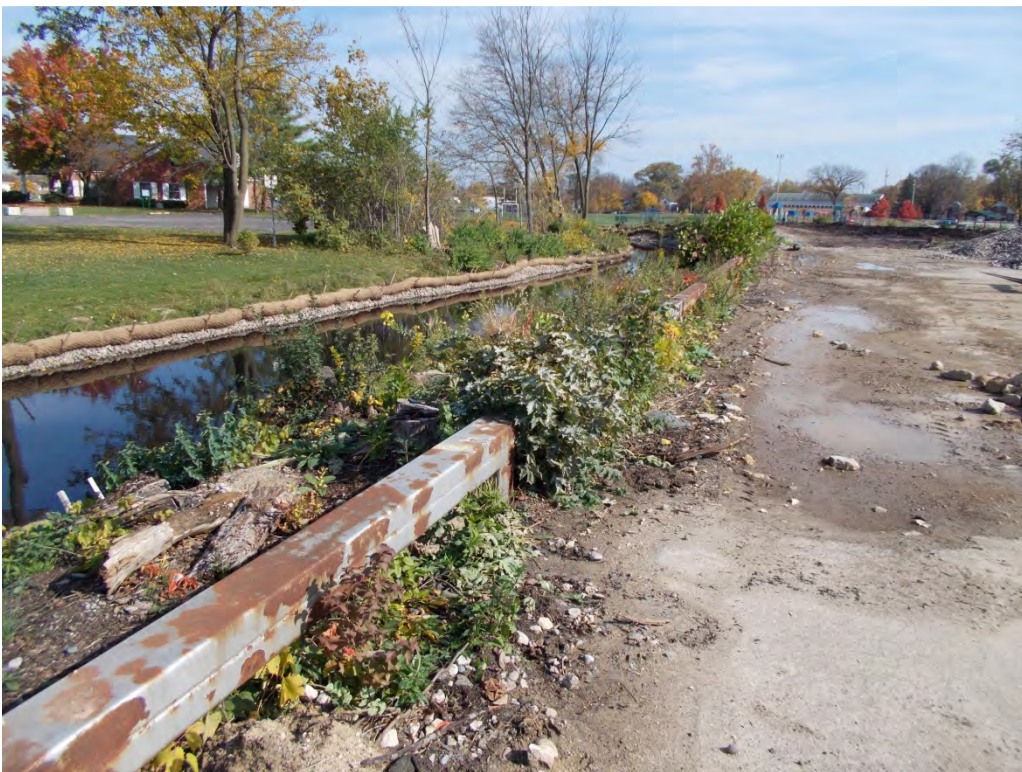
Designation: SA5-Axtell-S04

- There are still several failed section of railing.
- The structure does not appear to have been impacted during sediment removal.

West end of rail looking east

View of the rail looking east

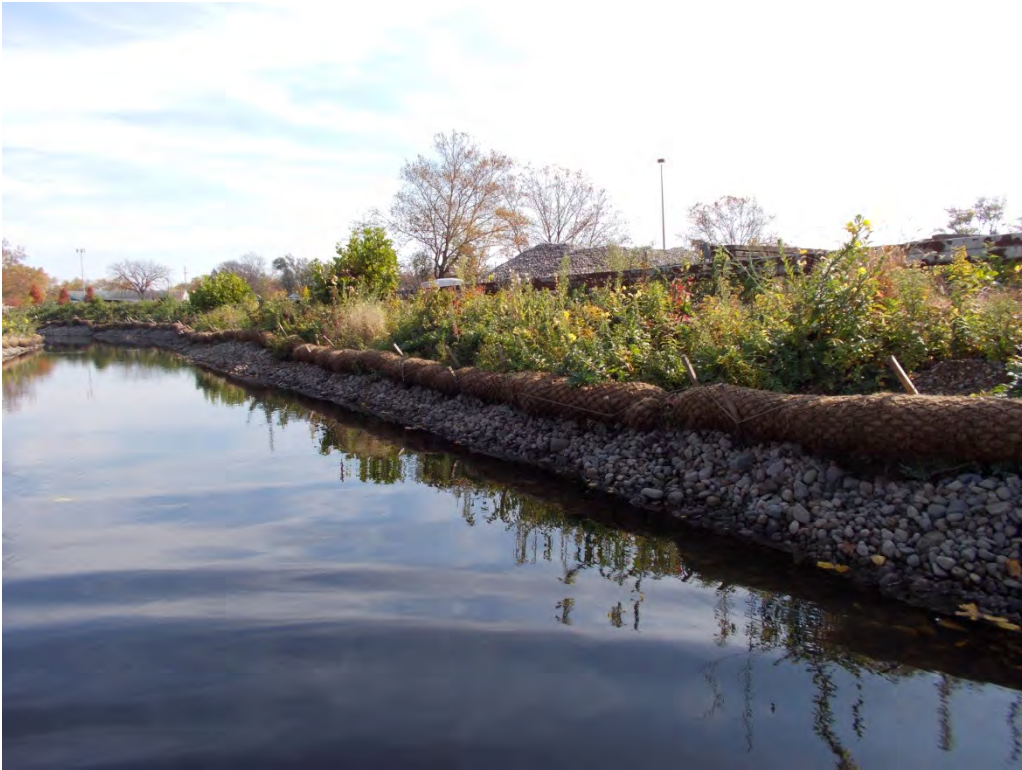
Designation: SA5-Axtell-S08

- The lower section of the spillway was removed in conjunction with sediment removal.
- The upper section does not appear to have been impacted during sediment removal.

View of bank restoration at the structure

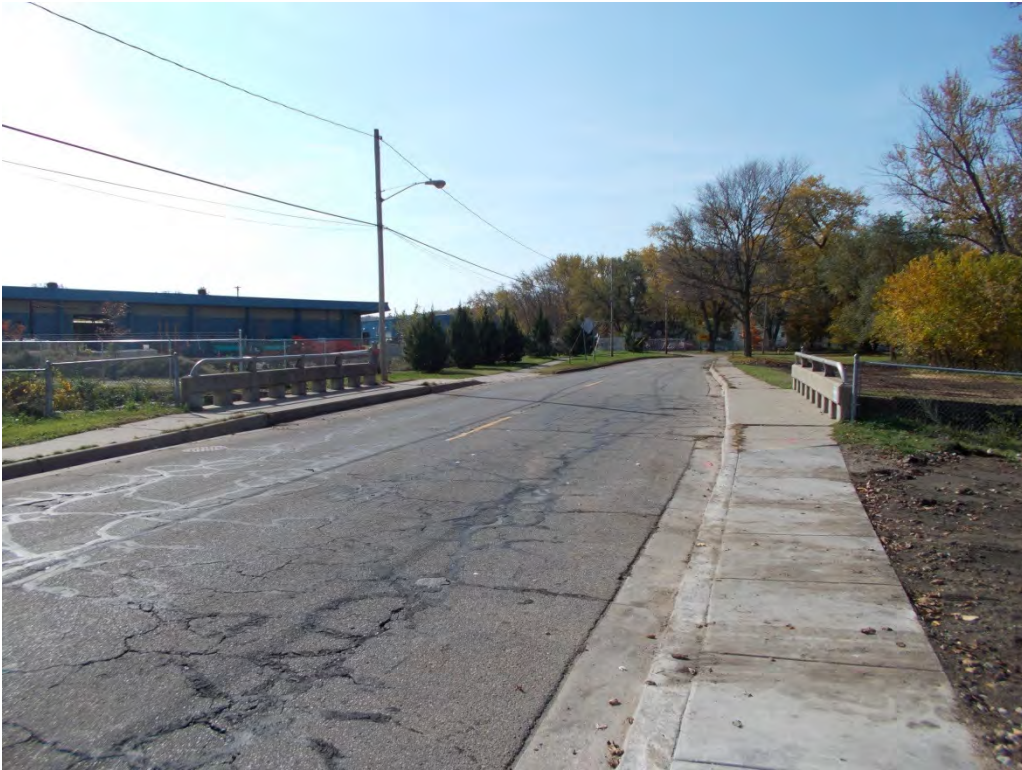
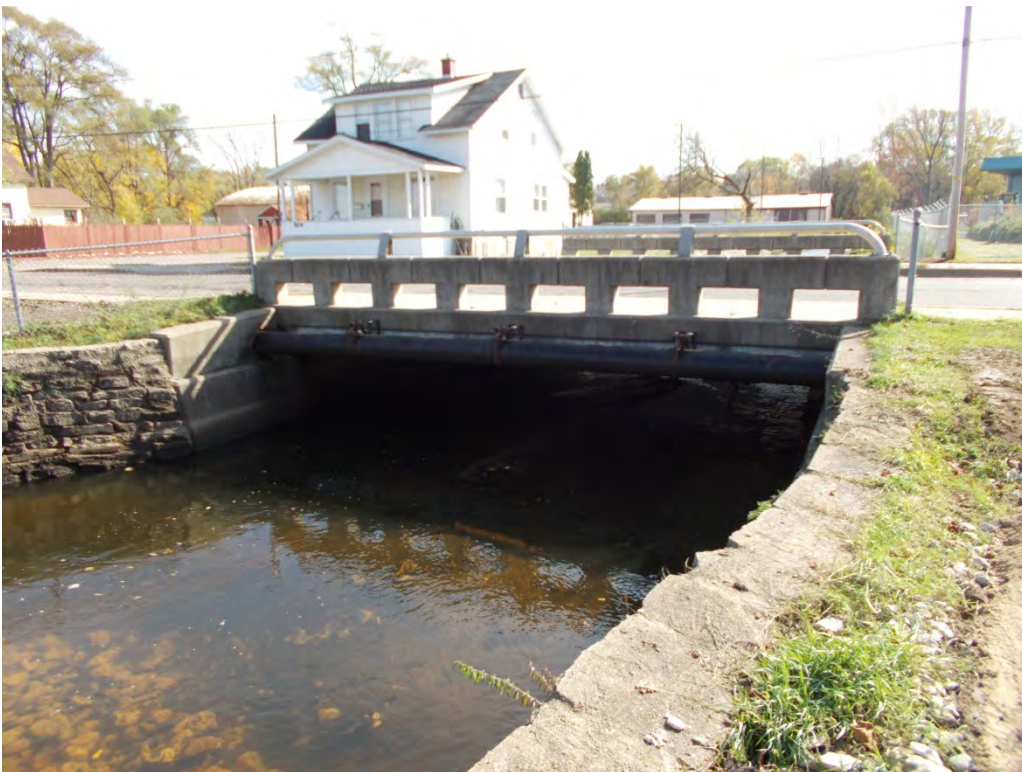
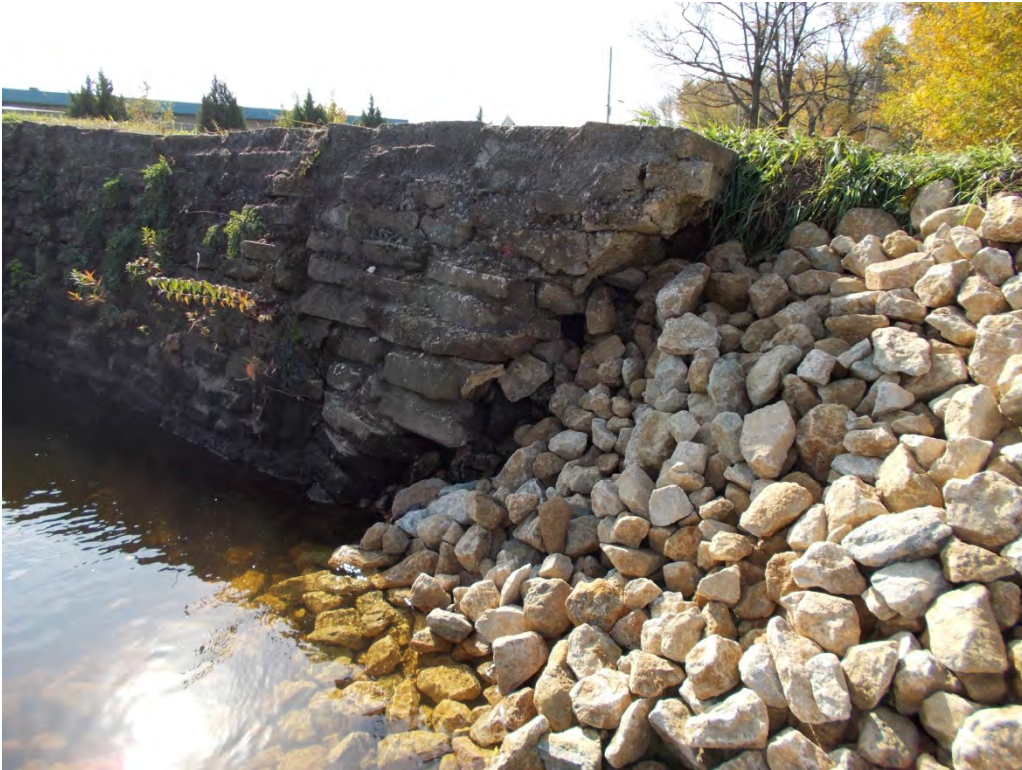
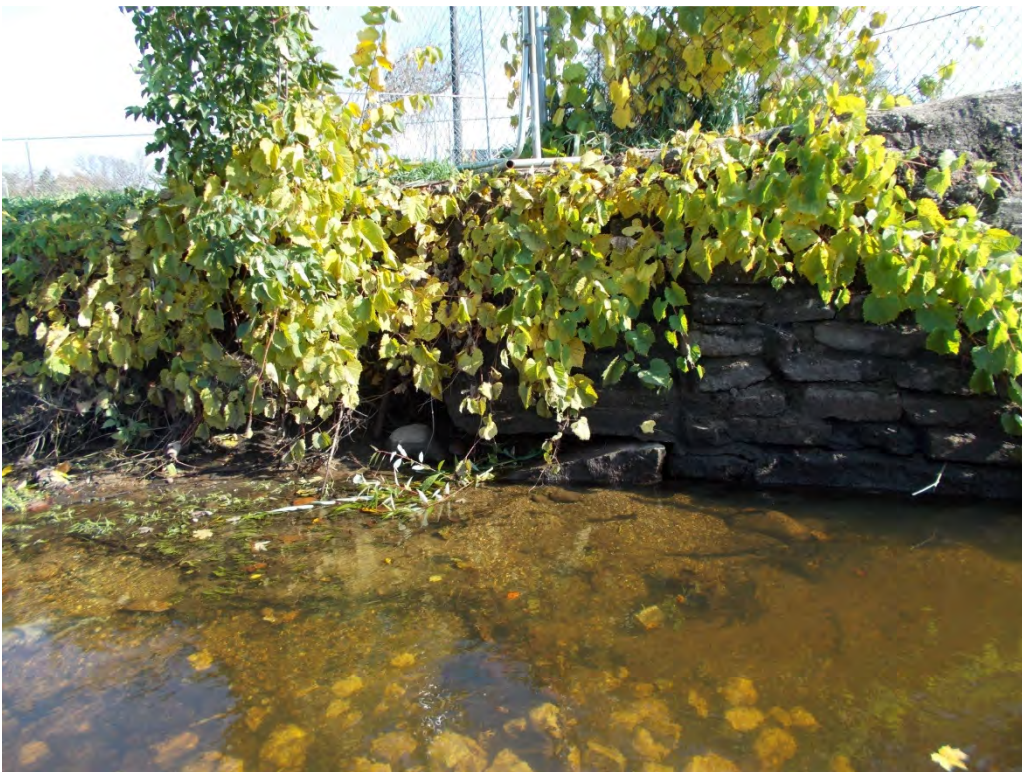
Designation: SA5-D-S01

- The curb head was removed in the northeast quadrant to facilitate access. It and the adjacent sidewalk appear to have been marked for replacement.
- Restoration is required in the northwest and northeast quadrants.
- The fence along the northwest block wall should be replaced.
- The structure itself does not appear to have been impacted during sediment removal.

View of the structure from the northeast approach area

Elevation view of structure from northwest bank

New riprap along northwest block wall

View of northeast block wall from the channel

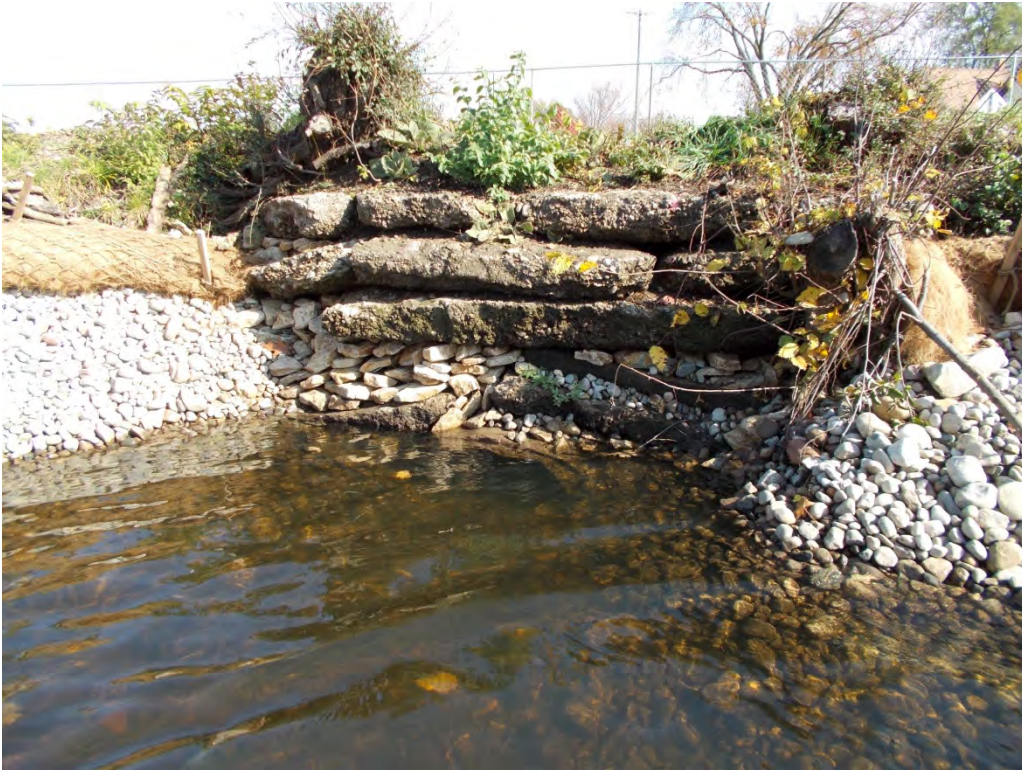
Designation: SA5-D-S02

- The rubble wall functions as the headwall for an outlet pipe below the waterline, which was not visible during previous evaluation. Neither the headwall nor pipe appear to have been impacted during sediment removal.
- The bank has been restored around the structure.

View of the structure from the channel

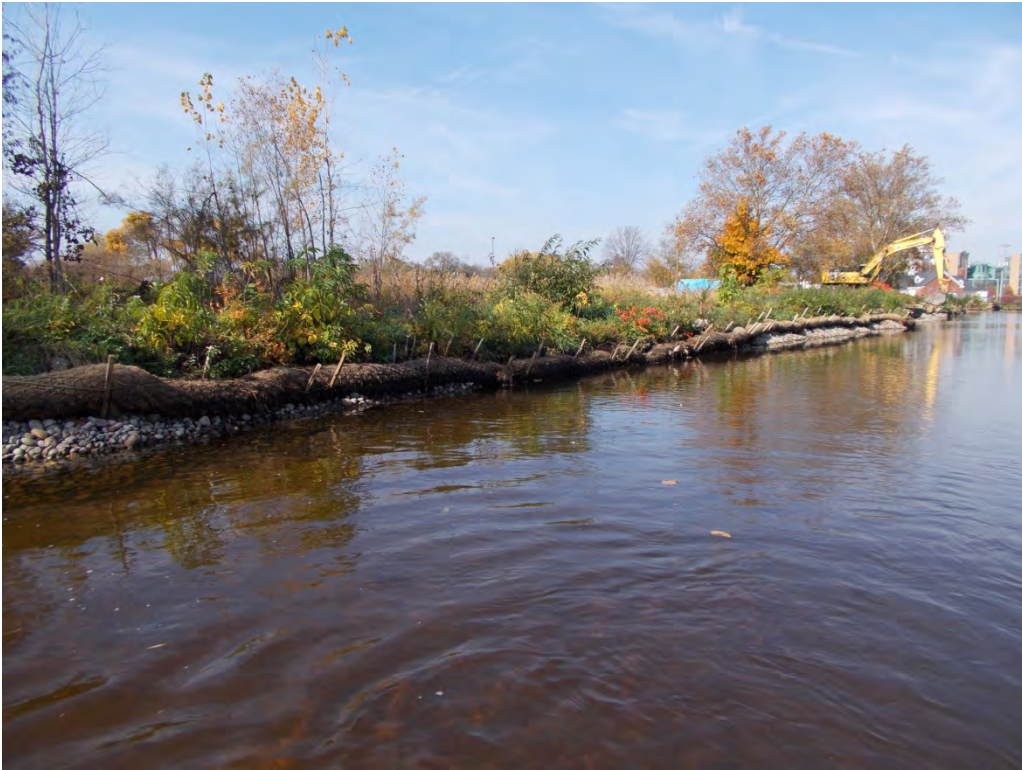
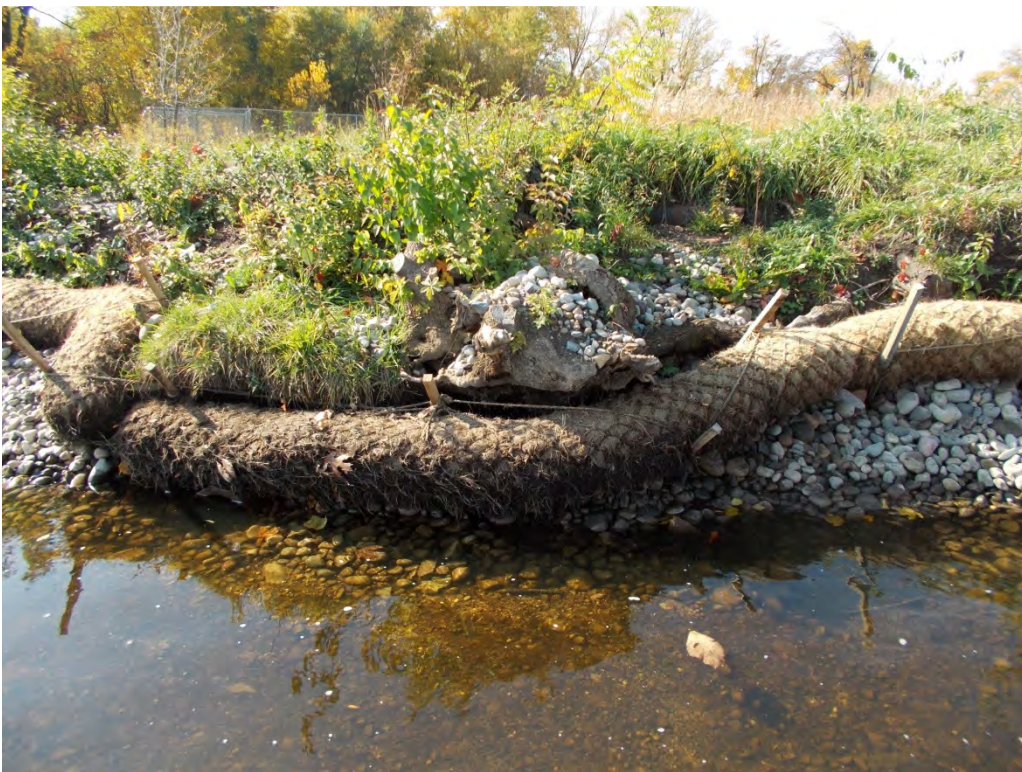
Designation: SA5-D-S03

- The concrete wall has been removed. It functioned as a headwall for a clay pipe outlet at the waterline, which was not visible during prior evaluation. The outlet does not appear to have been impacted during sediment removal.

Bank restoration in the previous wall location

Bank restoration at the structure

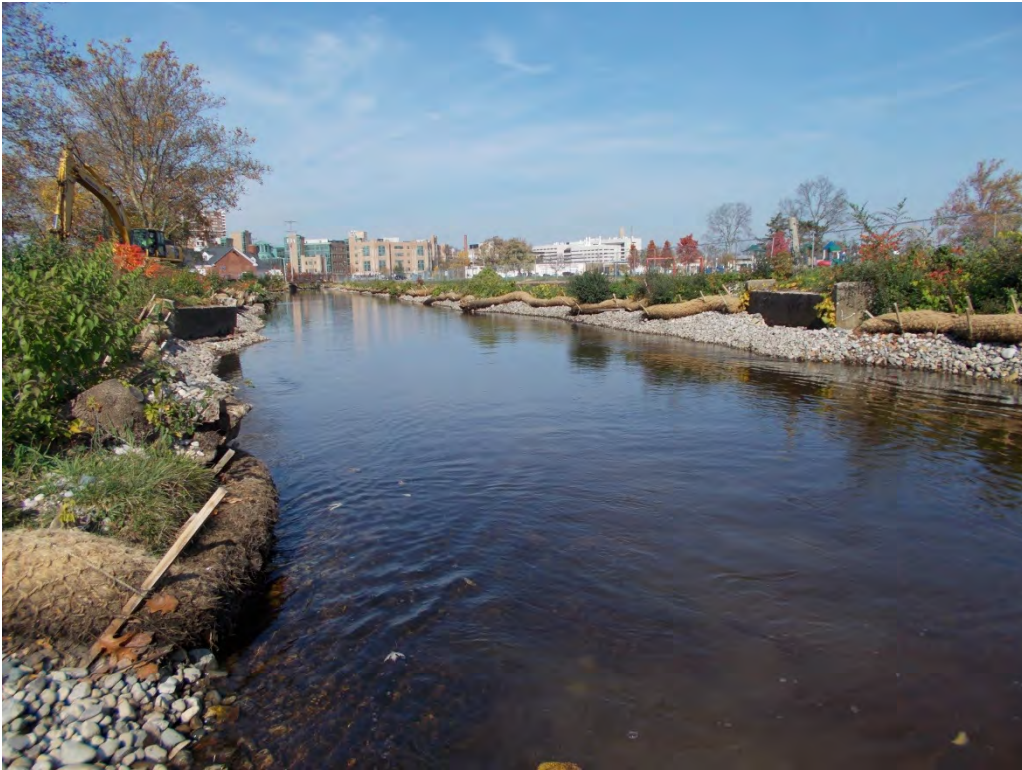
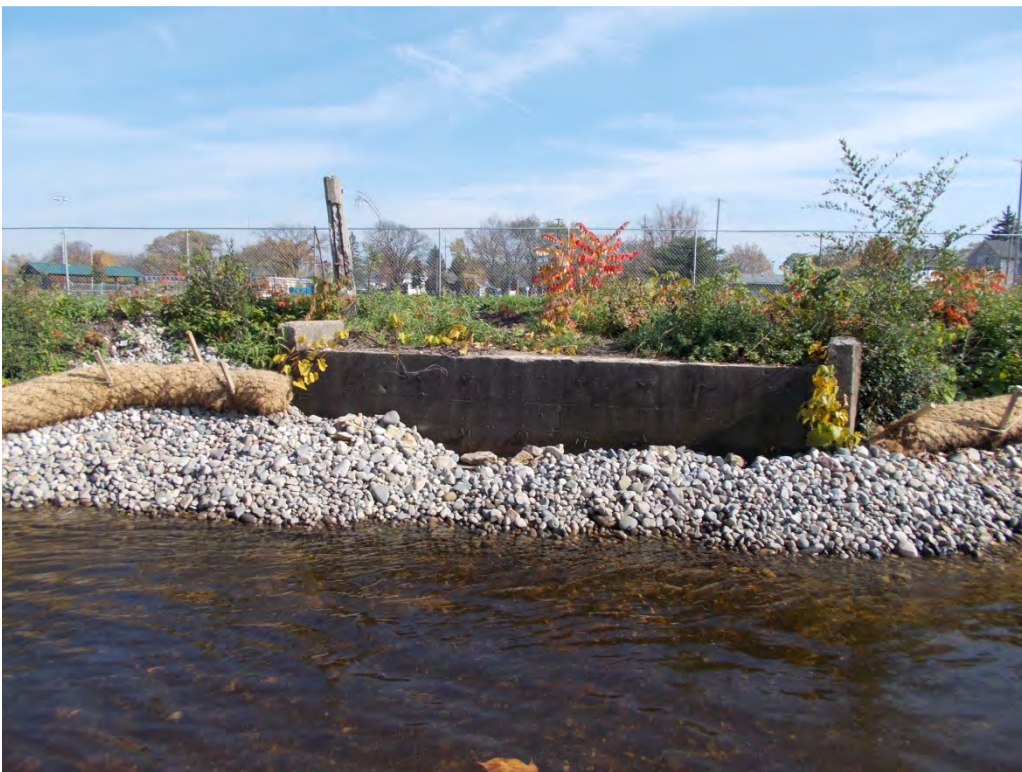
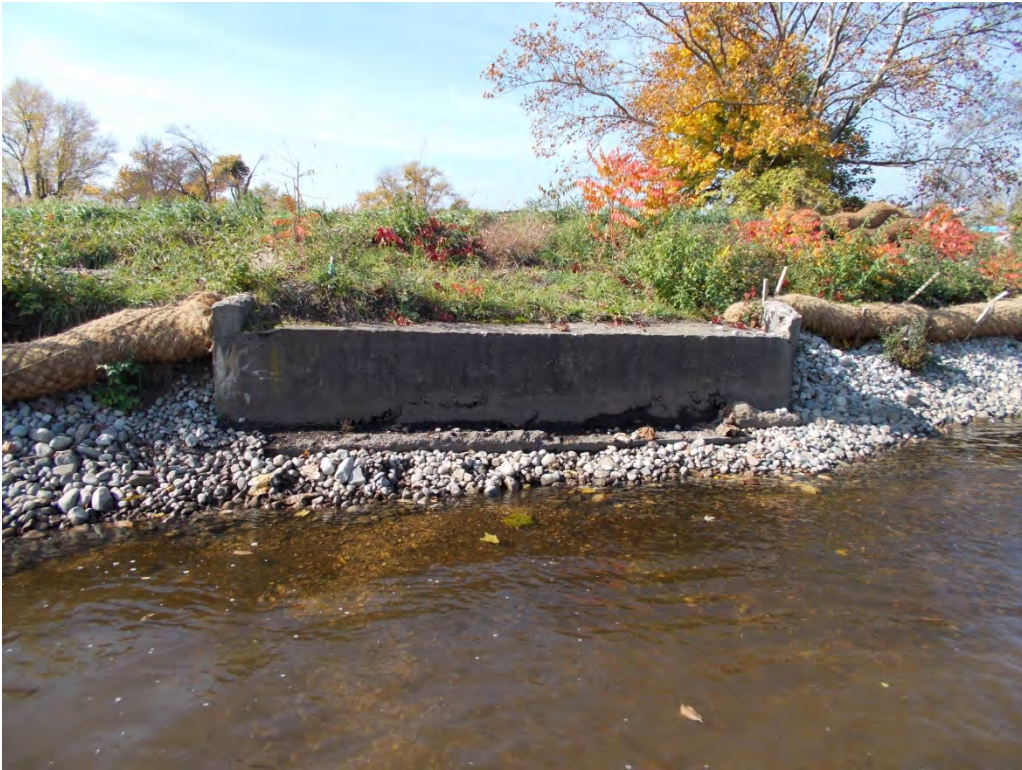
Designation: SA5-D-S04

- The structure does not appear to have been impacted during sediment removal. The banks have been restored around the remaining abutments.

View of structure from upstream channel

View of east abutment from channel area

View of west abutment from channel area

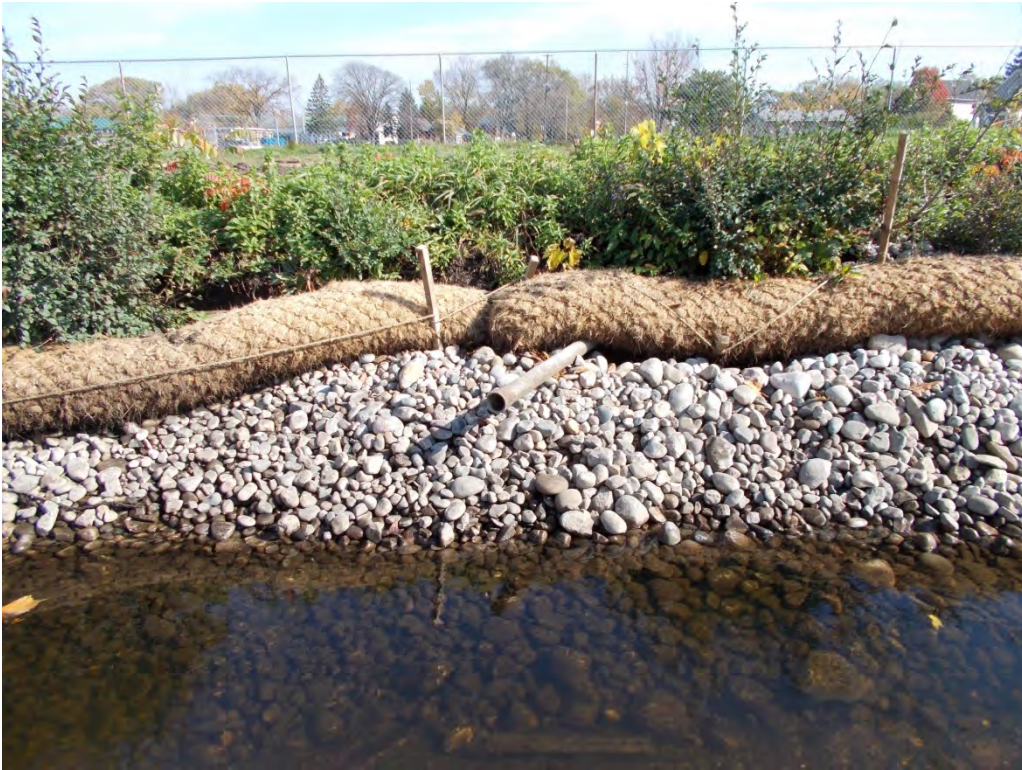
Designation: SA5-D-S05

- The structure does not appear to have been impacted during sediment removal.
- The bank has been restored around the structure.

View of the structure from the channel area

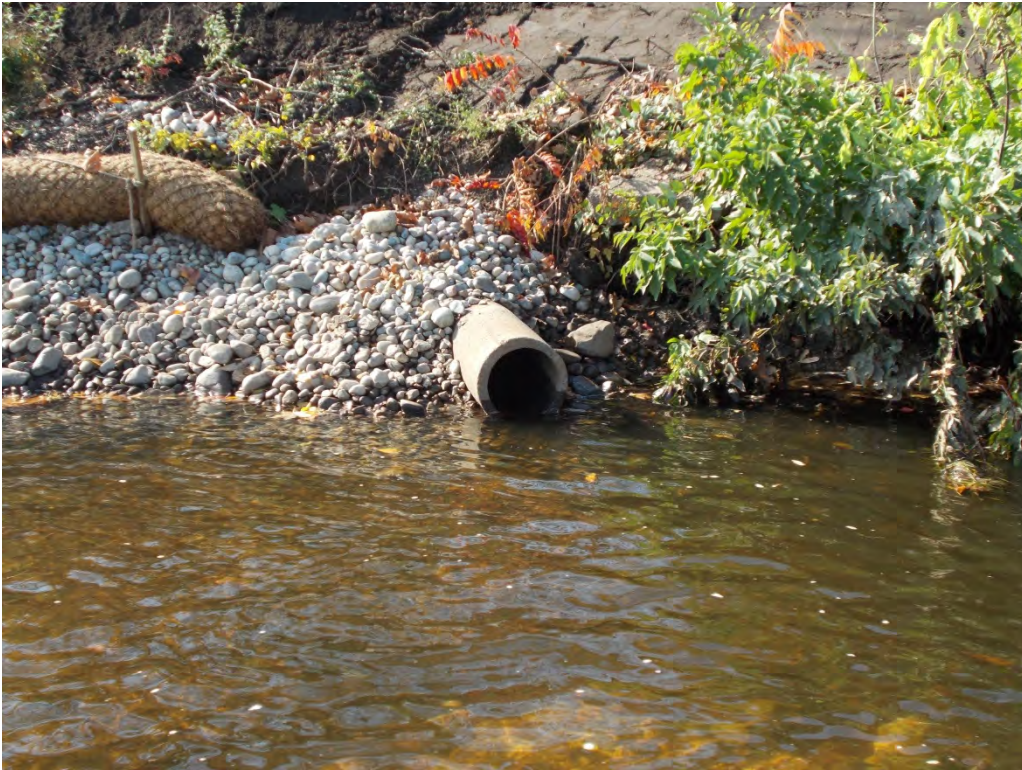
Designation: SA5-D-S06

- The failed end section has been removed. The remaining outlet pipe does not appear to have been impacted during sediment removal.

View of the structure from the channel

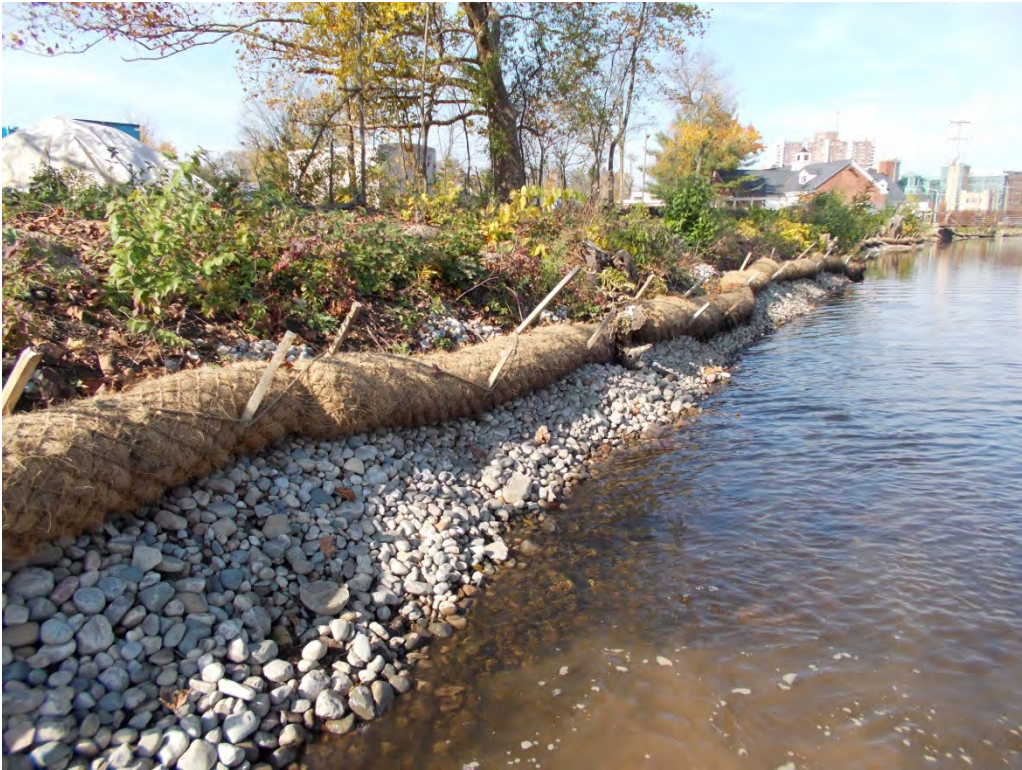
Designation: SA5-D-S07

- The structure was removed in conjunction with sediment removal operations.

View of bank restoration along the previous location of the structure

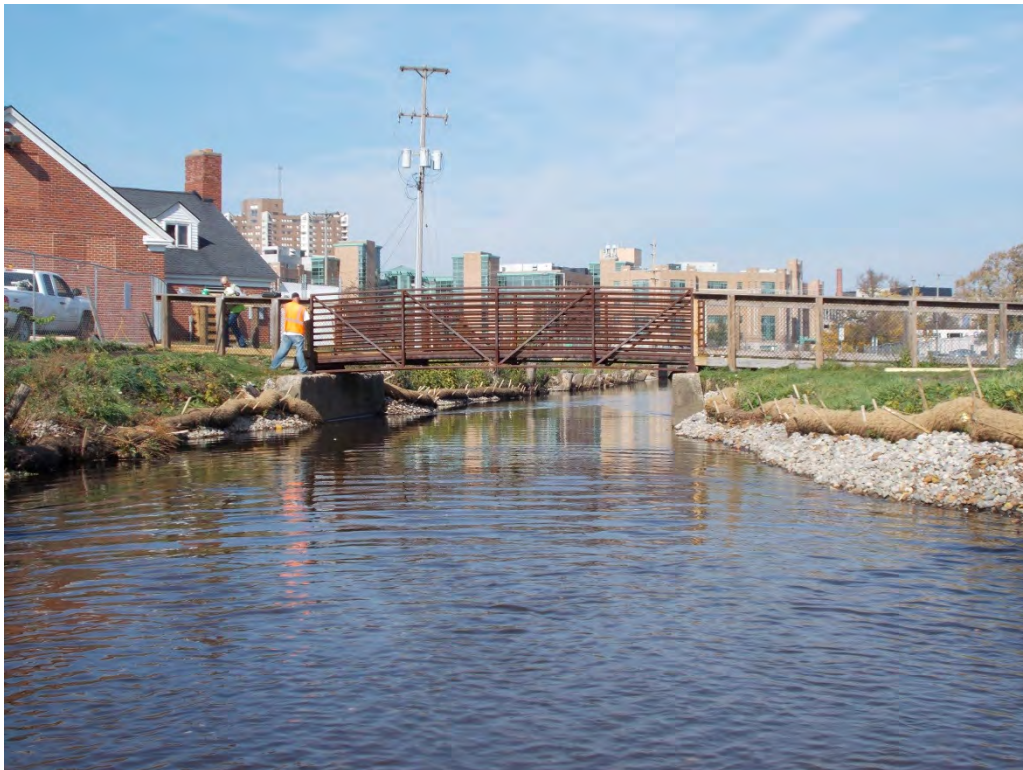
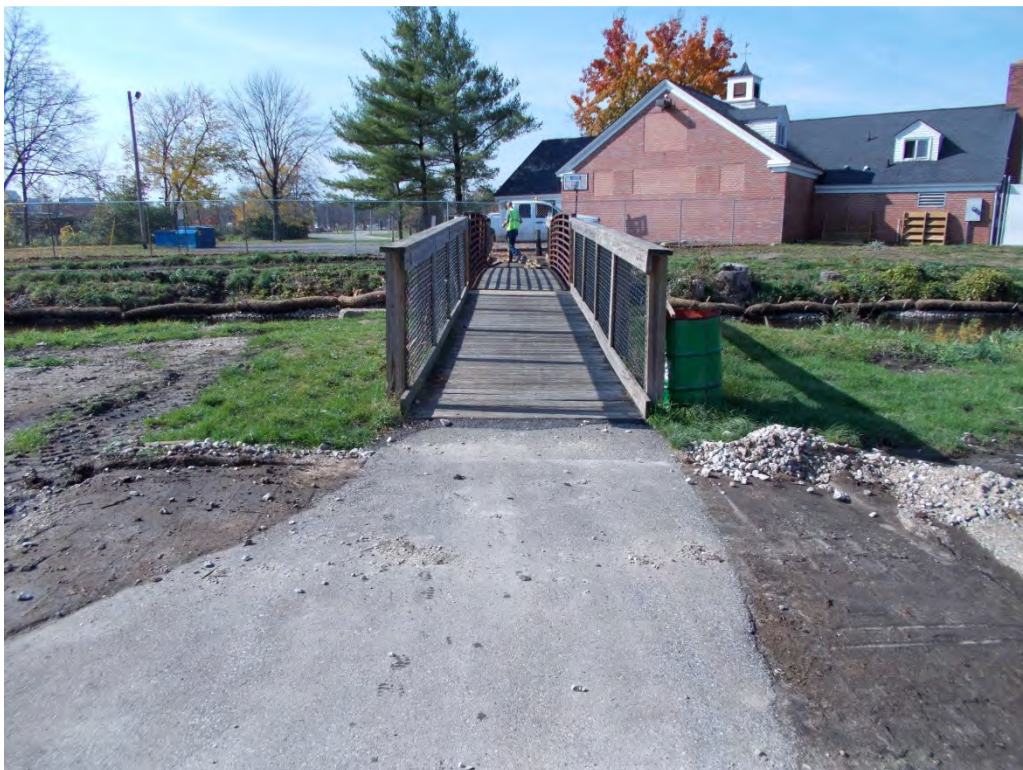
Designation: SA5-D-S08

- The superstructure was removed and replaced to accommodate sediment removal.
- EQM was in the process of restoring approach railings at the time of evaluation.
- The structure does not appear to have been impacted during sediment removal.

Elevation view of the structure from the upstream channel

View of structure from east approach

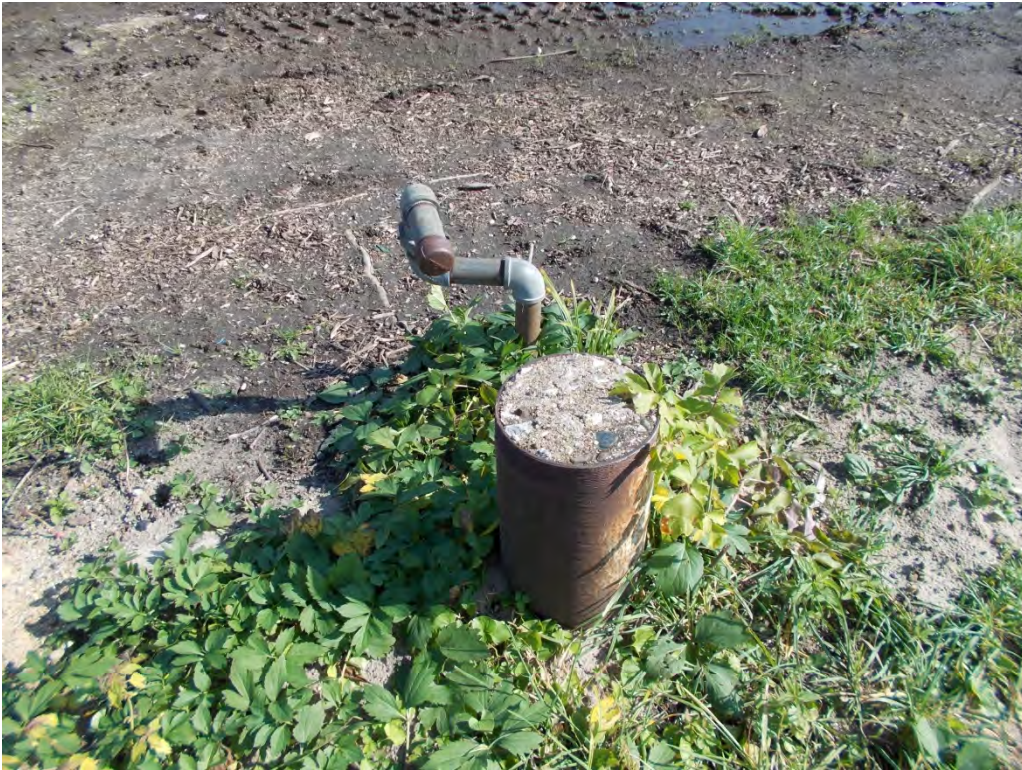
Designation: SA5-D-S10

- The west bollard appears to be leaning toward the channel more than it was prior to sediment removal, however, the structure appears to be abandoned and likely can be left in place.

East bollard and suspected abandoned gas main

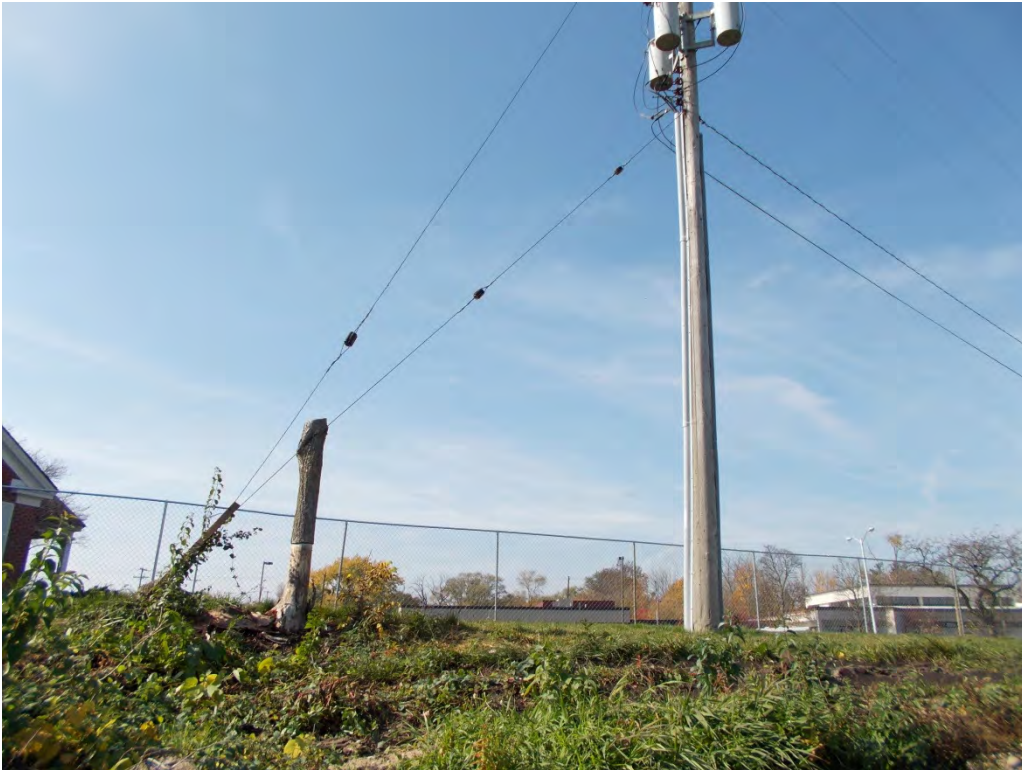
- The structure does not appear to have been impacted during sediment removal.

View of pole and guy from the channel area

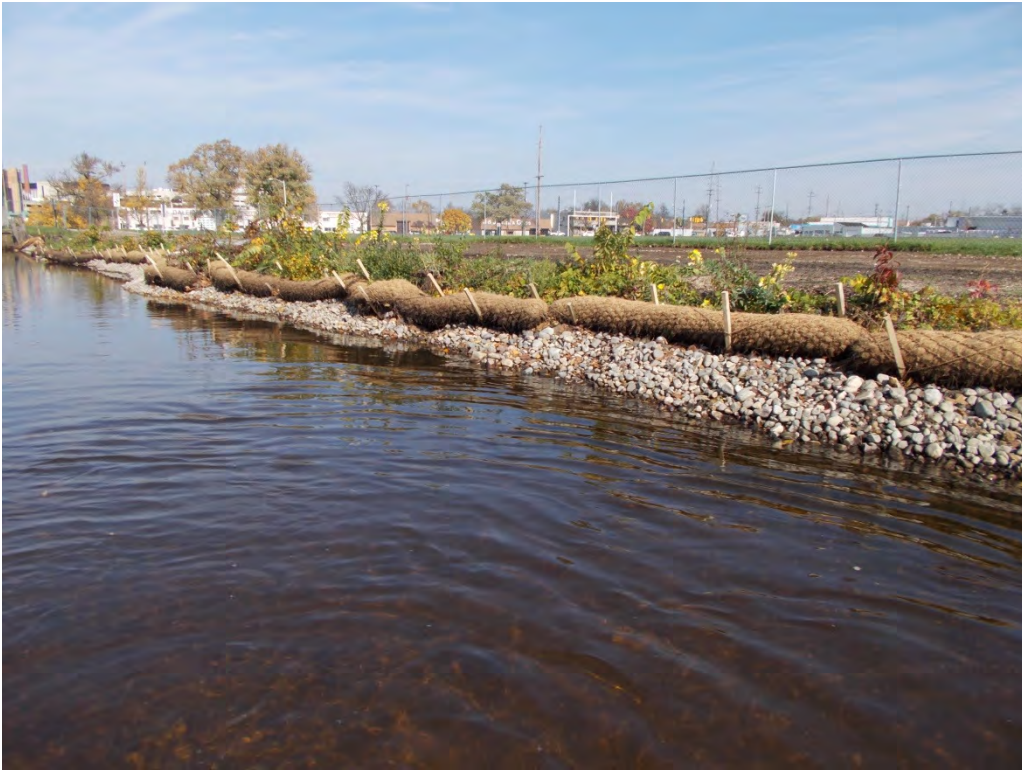
Designation: SA5-D-S12

- The structure was removed in conjunction with sediment removal operations.

Bank restoration in the area of the previous structure
